ARRI TECHNICAL NOTE P-1019

ARRIMAG 300E “Not Ready” August 1, 2000

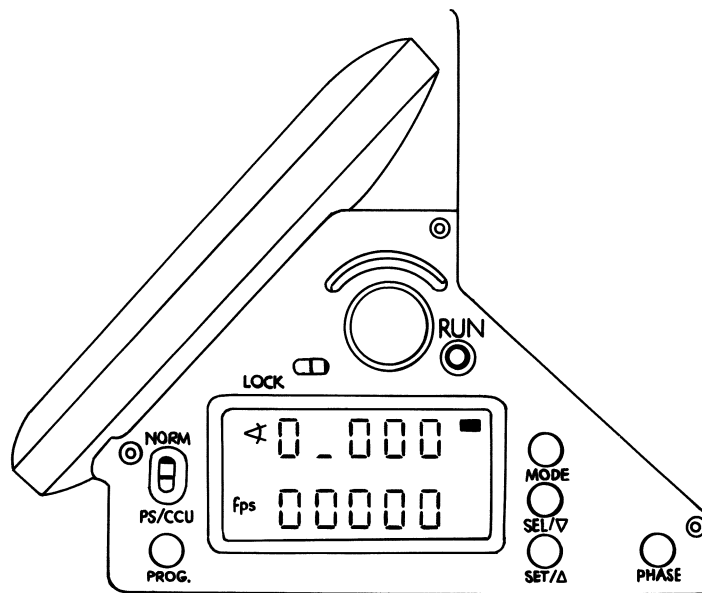
If a problem with the ARRIMAG 300E (the torque motor driven 1000' magazine for the 435) prevents the 435 from running, the camera's RUN LED will glow red, and the second digit on the top line of the display will turn into an underline (see graphic). This is the “ARRIMAGE 300E Not Ready” status, which could be caused by one of the following 5 conditions.
